**CWA COMPLIANCE EVALUATION INSPECTION REPORT  
U.S. ENVIRONMENTAL PROTECTION AGENCY, REGION 5**

**Purpose:** Compliance Evaluation Inspection

**Facility:** Ex. 6 (Personal Privacy) Farms, Inc.

**Date of Inspection:** October 2, 2014

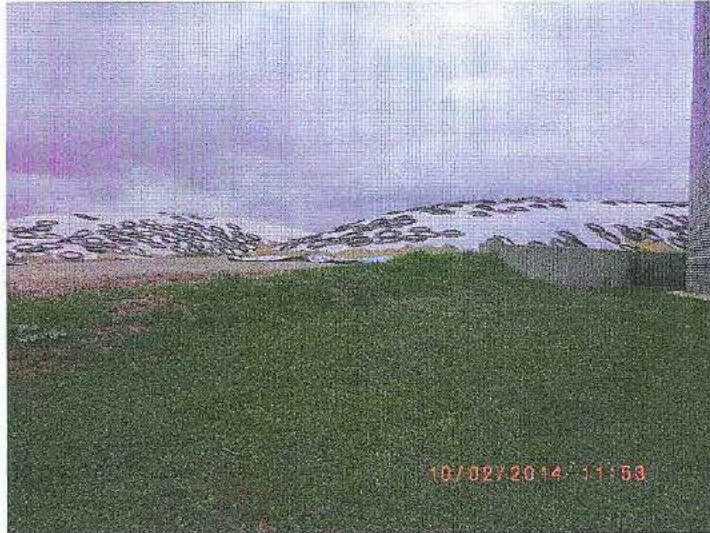
**1: IMGP1405**

**Description:** Covered silage.

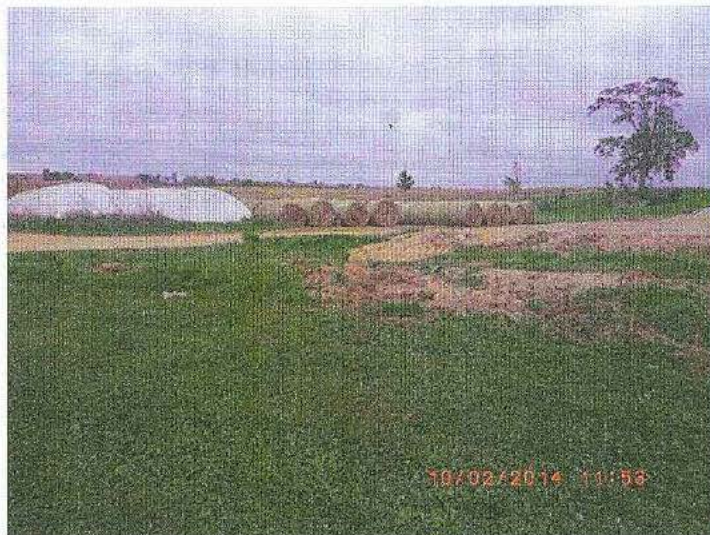
**2: IMGP1406**

**Description:** Haylage storage west of silage storage area and south of free stall barn. Haylage is all contained in plastic bags and rolls of haylage are sealed with a clear plastic material.

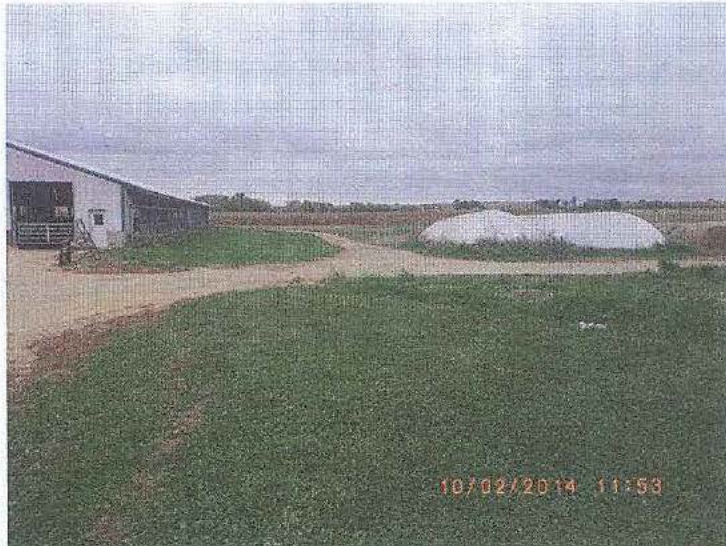
**3: IMGP1407**

**Description:** *Overland slope to the east from the silage storage area*

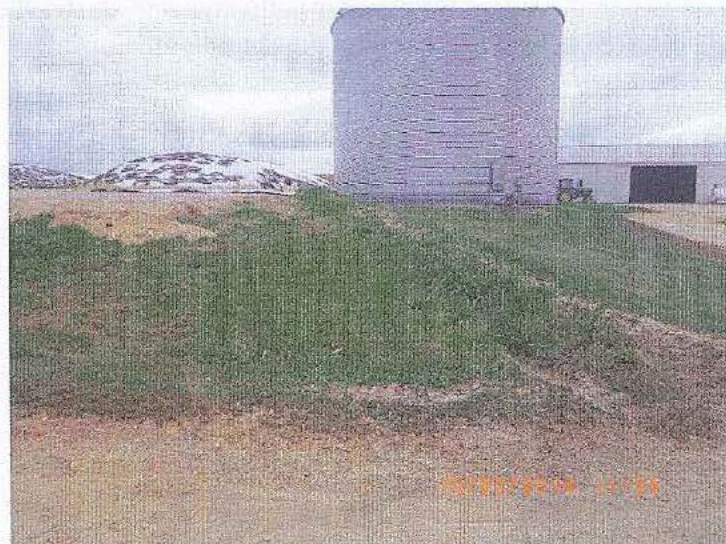
**4: IMGP1408**

**Description:** *Looking uphill to covered silage storage area.*

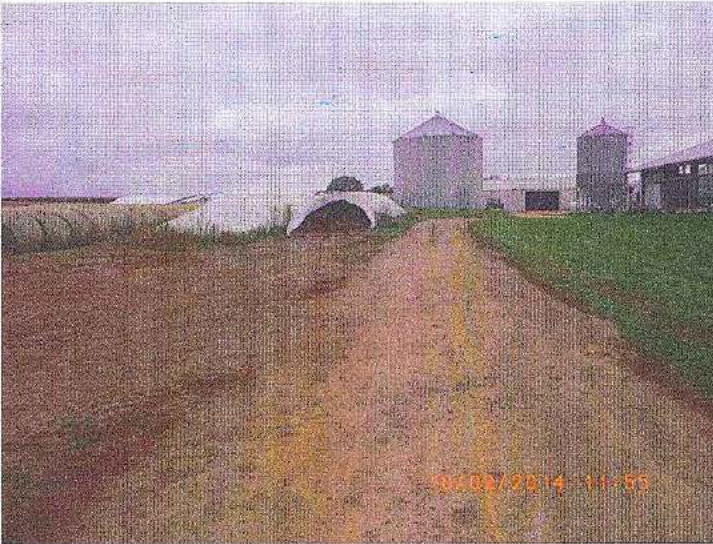
**5: IMGPI409**

**Description:** Looking uphill toward covered haylage storage area.

Photographs 5 and 6 provide evidence of no existing process wastewater pathways and shows the owners as using BMPs by keeping haylage covered/sealed and keeping the staging area clean after haylage withdrawals.

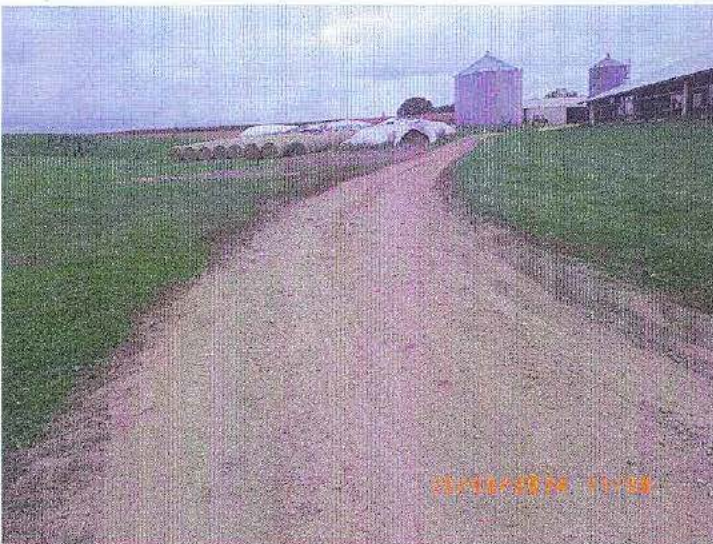
**6: IMGPI410**

**Description:** Looking uphill toward covered haylage storage area.

Looking west from this site the property topography is relatively flat but slopes toward the large expanse of open vegetated and crop areas and is located over a distance of approximately 1,000 feet to the unnamed tributary to Spring Branch.

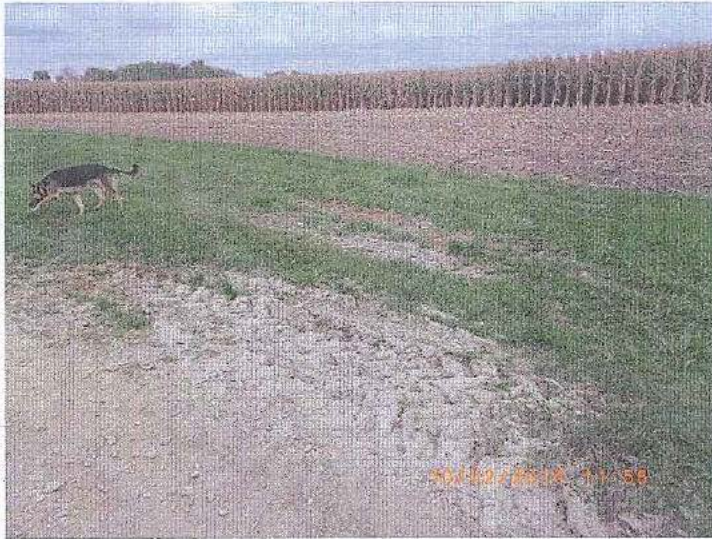
**7: IMGPI411**

**Description:** *Curvature point in the access road as the road turns north to the east side of the free stall barn, south of the concrete manure storage structure. Photograph 7 shows the expanse of vegetated and crop row areas toward the unnamed tributary to Spring Branch.*

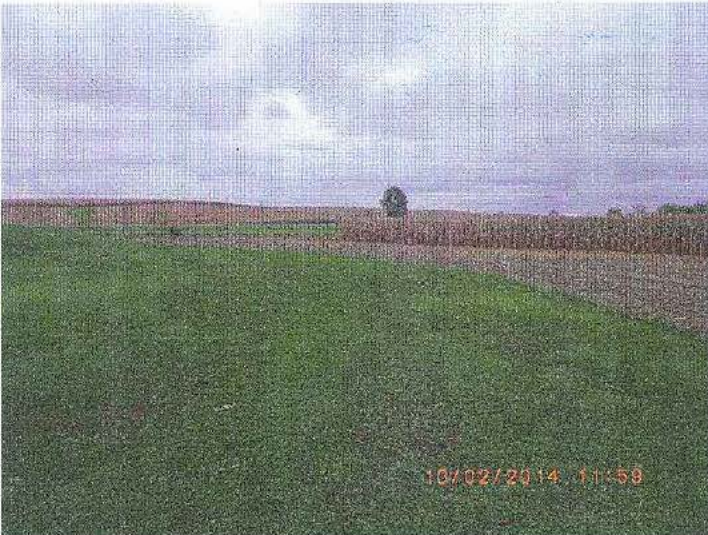
**8: IMGPI412**

Photo 8 illustrates additional extensive vegetated area west of the haylage stockpiles and north of access roadway. The unnamed tributary to Spring Branch lies approximately 1000 feet toward the horizon.

**Description:** *Vegetated area to the east of the concrete storage structure.*

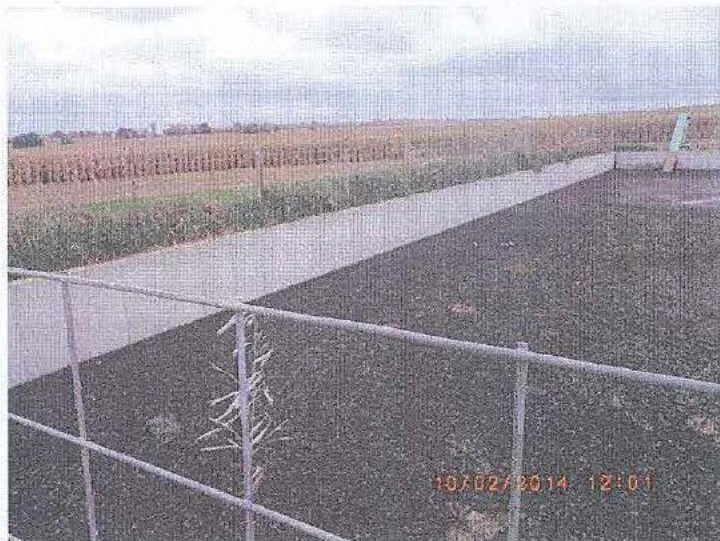
**9: IMGPI413**

Photos 9, 10 and 11 show a two foot freeboard remaining in the concrete storage structure at time of re-inspection. The storage structure is located immediately east and adjacent to the free stall barn. It is fenced and receives manure, used bedding and process wastewater from the free stall barn.

**Description:** Concrete manure storage structure immediately adjacent and east of the free stall barn.

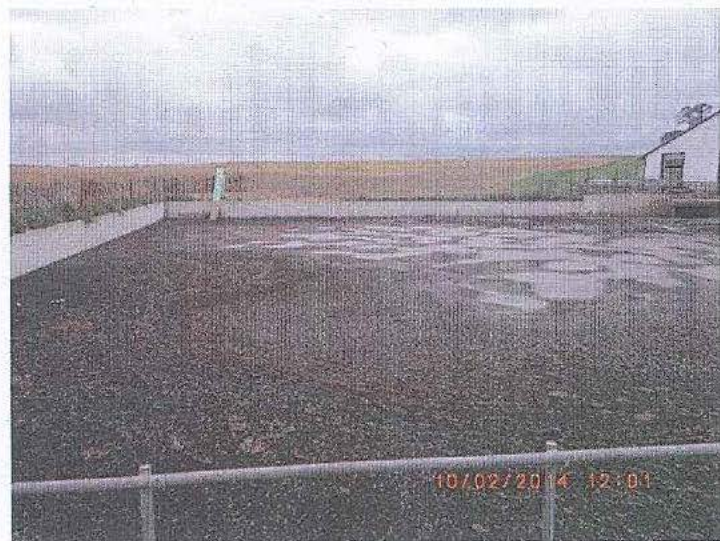
**10: IMGPI414**

**Description:** Concrete manure storage structure immediately adjacent and east of the free stall barn.

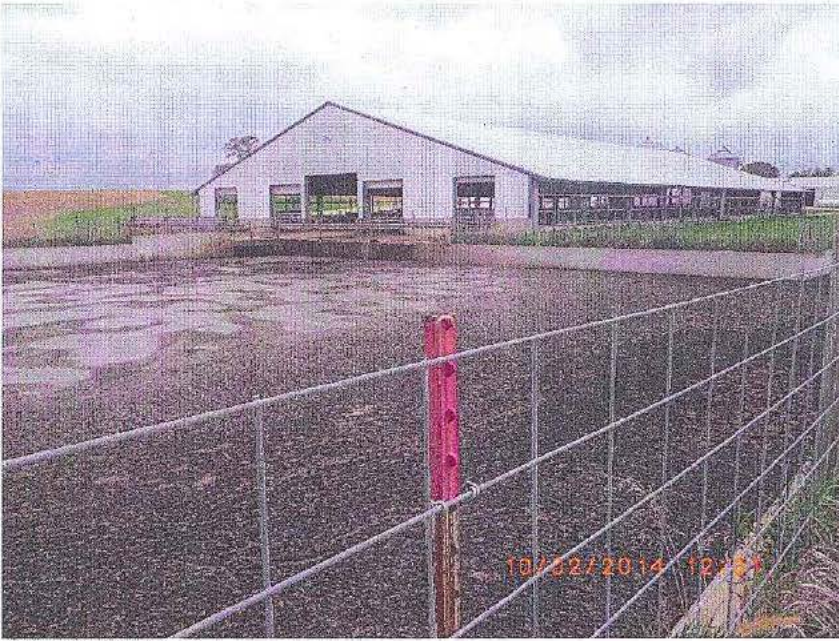
**11: IMGP1415**

**Description:** Concrete manure storage structure immediately adjacent and east of the free stall barn.

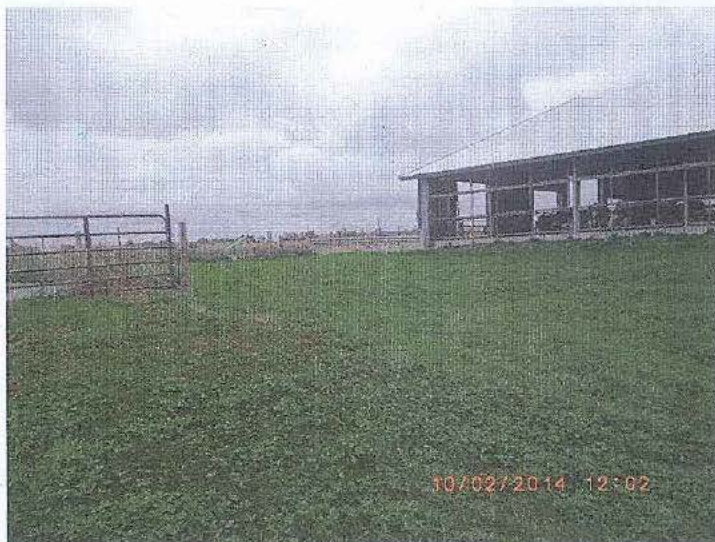
**12: IMGP1416**

Photos 12 and 13 show the area immediately north of the free stall barn.

During the re-inspection, EPA noted that there was now a healthy vegetated area to the north of the free stall barn that during the previous inspection was found to contain pockets of process wastewater with a pathway that ran toward the unnamed tributary to Spring Branch. The unnamed tributary to Spring Branch is located to the north of the areas in the photos.

No existing pathways of process wastewater were found at time of re-inspection and the area was graded to level the topography removing ruts and pockets.

**Description:** Free stall barn

The new berm as described earlier (Attachment A) was constructed by the owner since EPA's last inspection to intercept potential runoff from the silage storage area through the outdoor heifer pen area and to the area north of the free stall barn. Additionally, the owner had depopulated the outdoor heifer pen (old hog house on Attachment A) and has incorporated BMPs to keep the feed mixing pad clean after use. Ex. 6 (Personal Privacy) now cleans up the distillers in the feed mixing pad after each use and stores the distillers in the commodities shed. The initial EPA inspection found that uncovered distillers were stored outside and south of the hay storage barn (Attachment A). A process wastewater pathway was found at the initial inspection that ran through the mixing pad area to the east and migrated toward a drainage swale directing stormwater runoff to the unnamed tributary to Spring Branch.

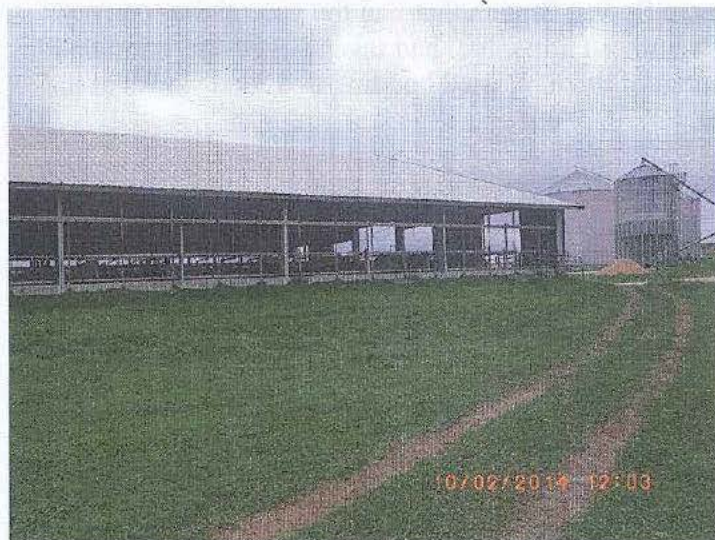
**13: IMGP1417**

**Description:** Free stall barn

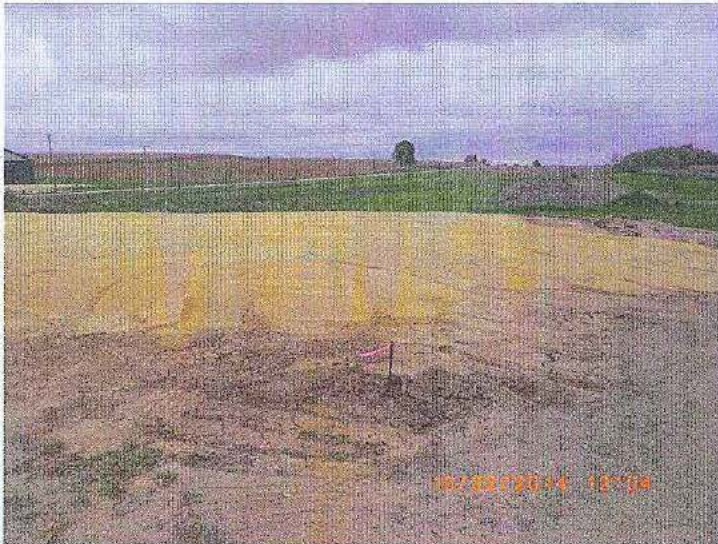
**14: IMGP1418**

Photo 14 shows the graded area north of the free stall barn.

**Description:** Graded area south of free stall barn.

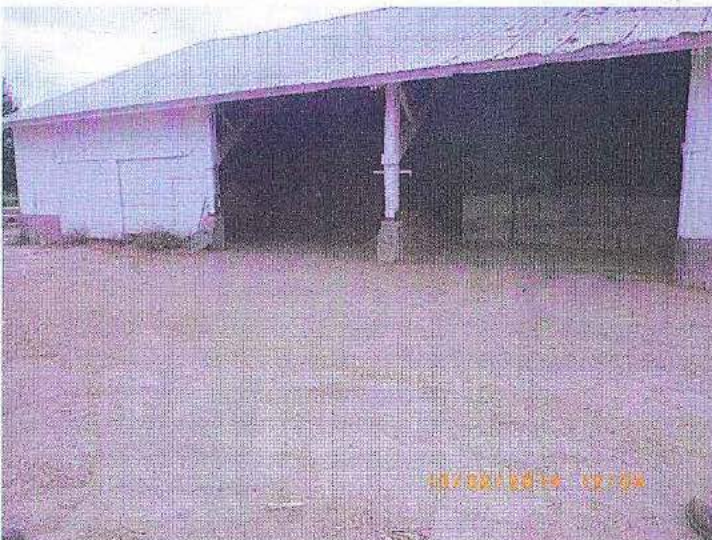
**15: IMGP1419**

**Description:** Indoor distillers storage in commodities barn at pad mixing area.

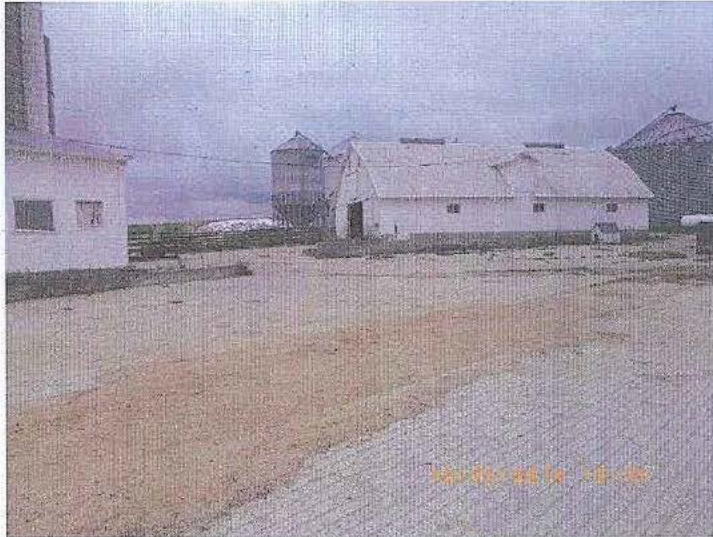
**16: IMGP1420**

**Description:** Distillers mixing pad area.

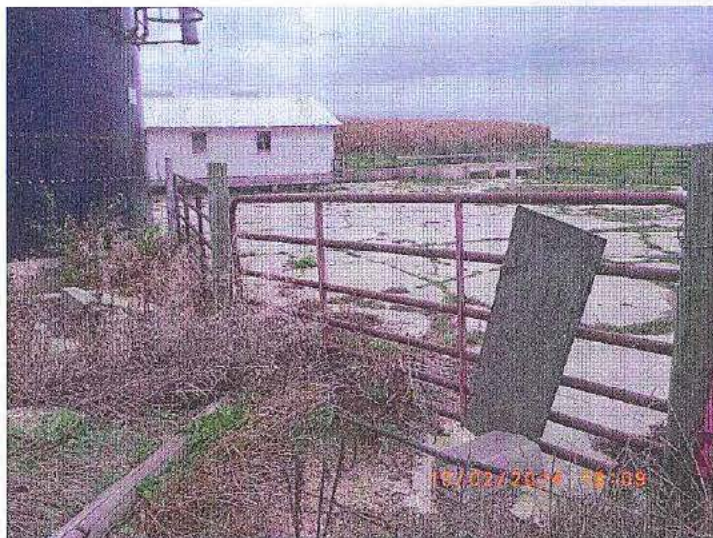
**17: IMG1421**

**Description:** Outdoor heifer pen.

The initial March 9, 2012 inspection found that a potential process wastewater runoff pathway was routing with surface stormwater runoff from the north and intersecting with portions of the west side of the outdoor heifer pen with uncontained manure. This runoff was directed into a storm manhole. From the manhole, the flow went under the access roadway through a crossroad culvert that discharged into the unnamed tributary to Spring Branch.

During the re-inspection on October 2, 2014, EPA noted that all animals have been removed from the outside heifer pen (Photos 17 and 18) on the north farm with the exception of the calves in the calf shed. The pen area was found to be clean of manure, used bedding or feed on the day of the inspection.

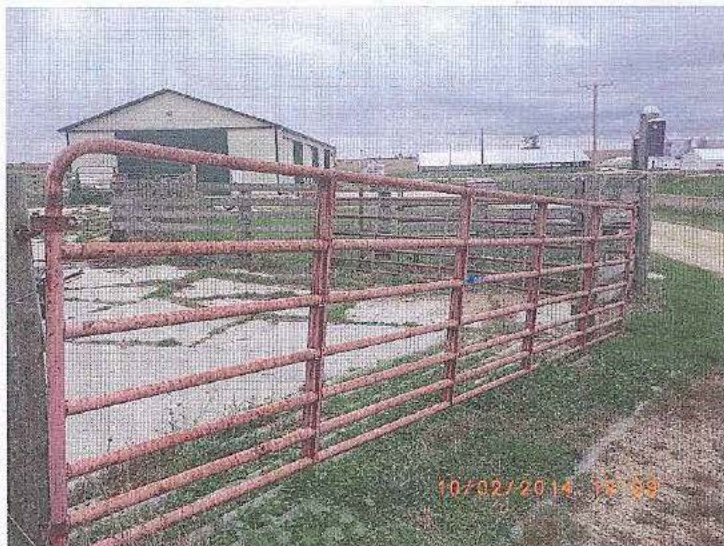
**18: IMGP1422**

**Description:** Animals have been removed from the outdoor heifer pen.

(Note the new equipment building in the background of photograph 18 that had been erected since the initial EPA inspection).

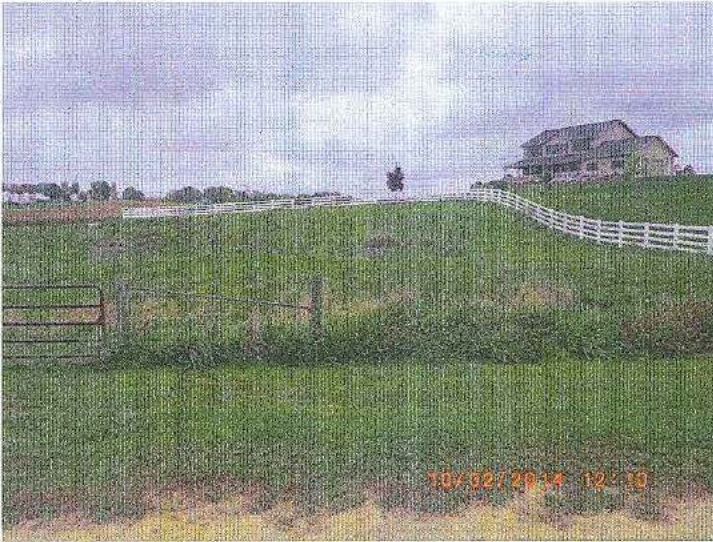
**19: IMGP1423**

Photographs 19, 20, 21 and 22 show that animals have been removed from the pasture and feedlot area.

The pasture has since been successfully reseeded with established vegetation.

**Description:** *Unnamed tributary flowing south through now-vegetated land that was denuded of vegetation at previous March 9, 2012 inspection.*

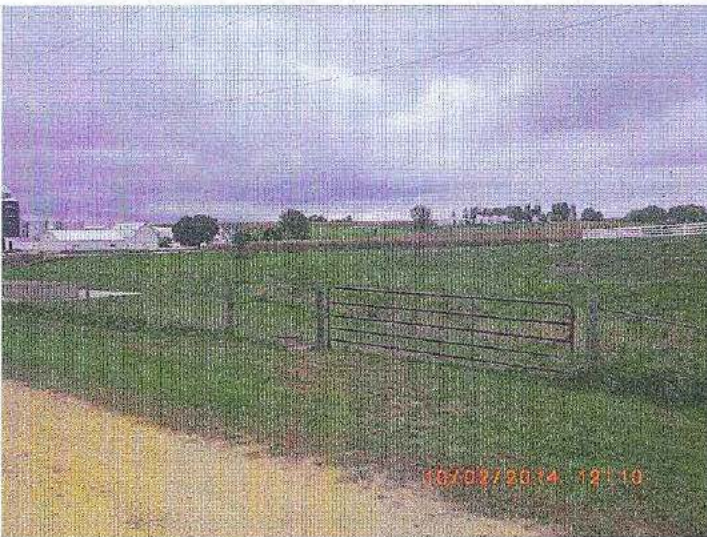
**20: IMGP1424**

**Description:** *New vegetated pasture bisected by unnamed tributary to Spring Branch.*

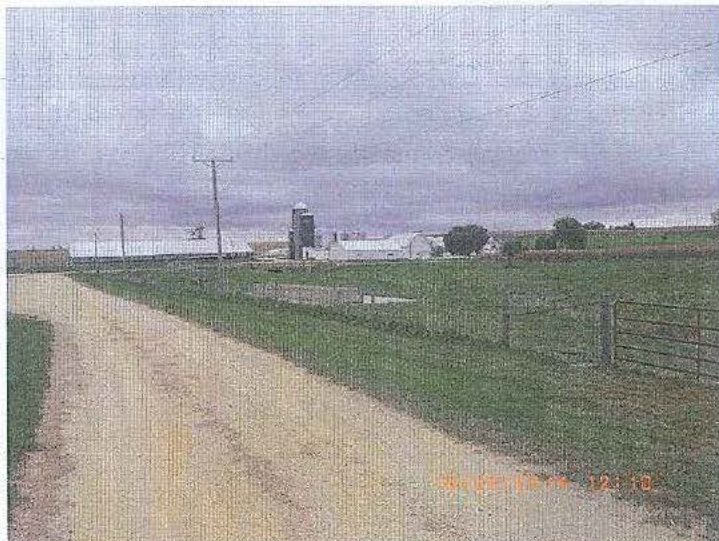
**21: IMGP1425**

**Description:** Access road to north farm.

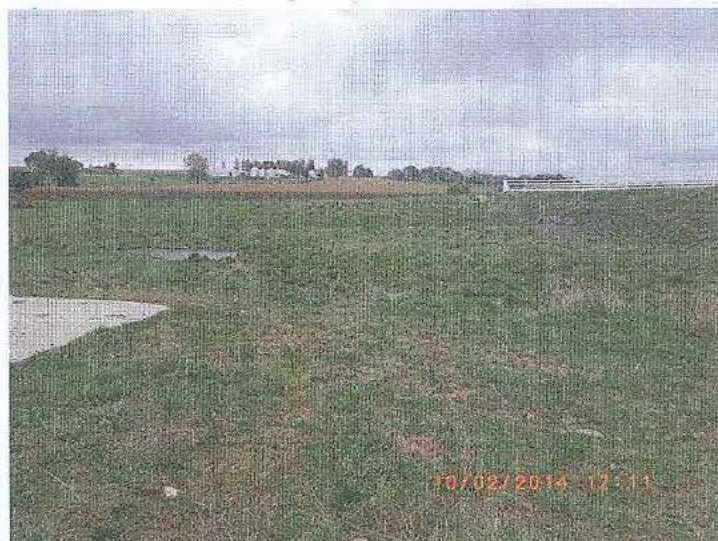
**22: IMGP1426**

**Description:** Unnamed tributary flowing south through new vegetated pasture to Spring Branch.

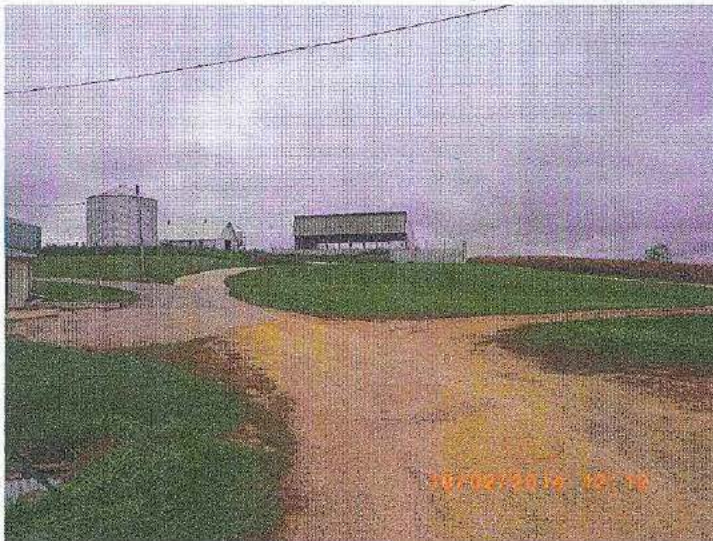
**23: IMGP1427**

**Description:** Access road to north farm and owner's residence showing calf shed and new manure storage structure to the southwest of calf shed.

As an interim measure <sup>Ex. 6 (Personal Privacy)</sup> Farms, Inc. plugged the holes found in the containment walls at the calf barn shortly after the initial inspection. Since then, a new concrete scrape alley with adequate concrete containment barriers has been constructed as part of the capital improvements at the north farm.

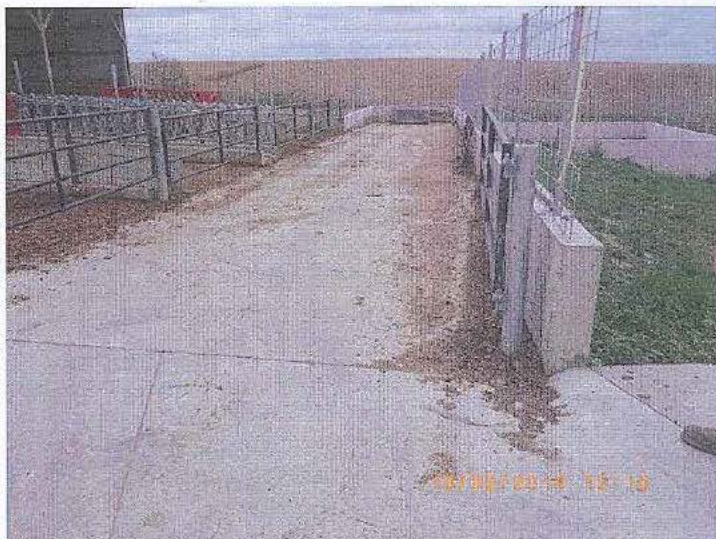
**24: IMGP1428**

**Description:** New cleaning alley with barrier curbing/wall from calf shed to new concrete manure storage structure. The calf shed non-containment issue has been resolved with the construction of a new scraping alley with containment curbs that leads to a new concrete, manure storage structure for the calf shed.

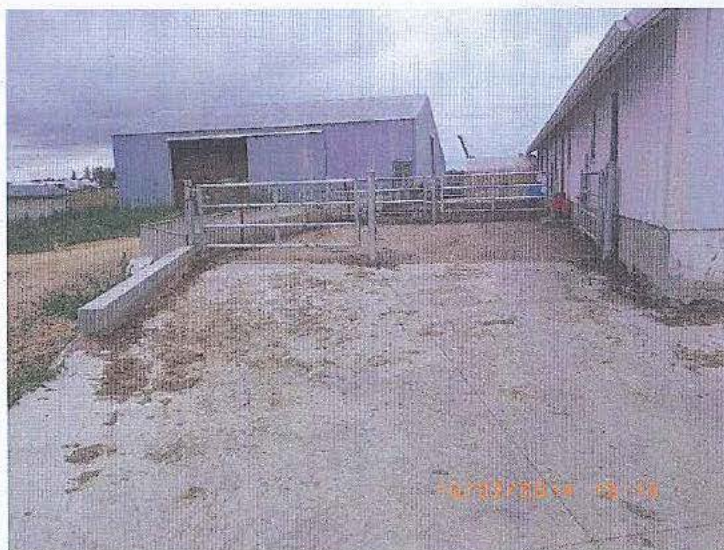
**25: IMGP1429**

**Description:** Calf shed east outside area and new concrete cleaning apron with barrier curbs.

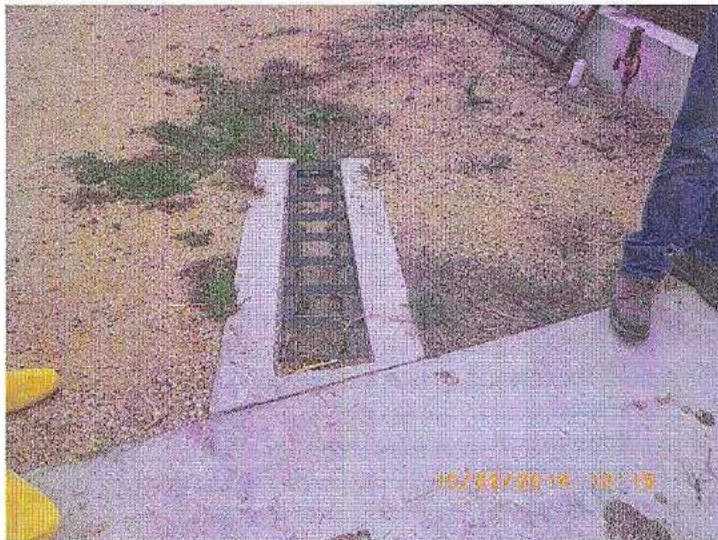
**26: IMGP1430**

**Description:** Drainage gutter discharge structure from calf barn roof gutters. This structure accepts roof runoff from the calf shed and directly discharges the storm water under the concrete scrape alley and apron to avoid intersection with any possible sources of process wastewater materials from migrating offsite to the south.

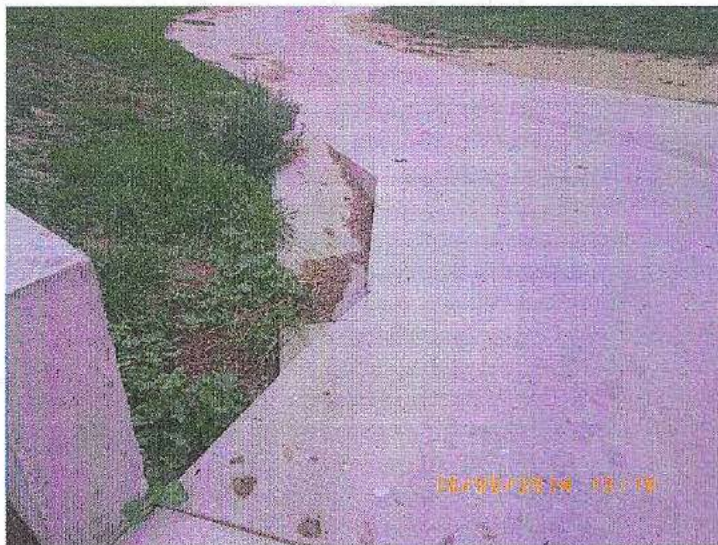
**27: IMGP1431**

**Description:** New access pavement to the cleaning alley and new concrete manure storage tank at calf shed location.

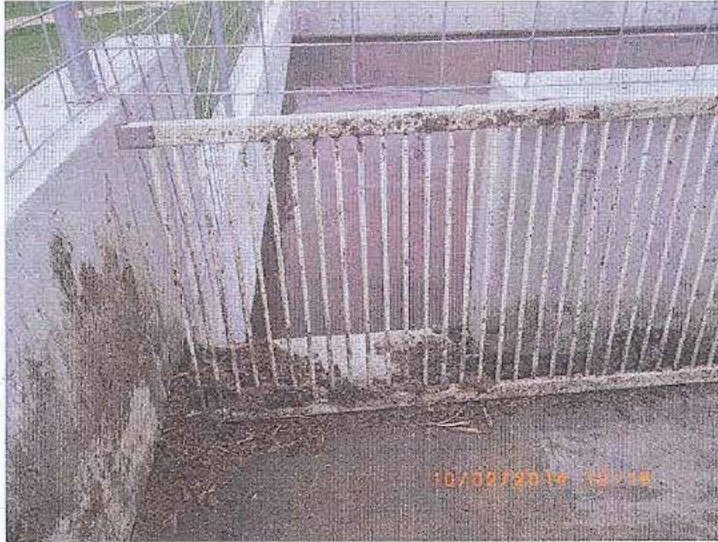
**28: IMGP1432**

**Description:** *Cleaning alley and barrier structure allowing for the separation of solids and for pushing of manure into the new concrete manure storage structure. The new concrete north farm manure storage manure/used bedding is transported to the south storage pit. This was last done in May, 2014.*

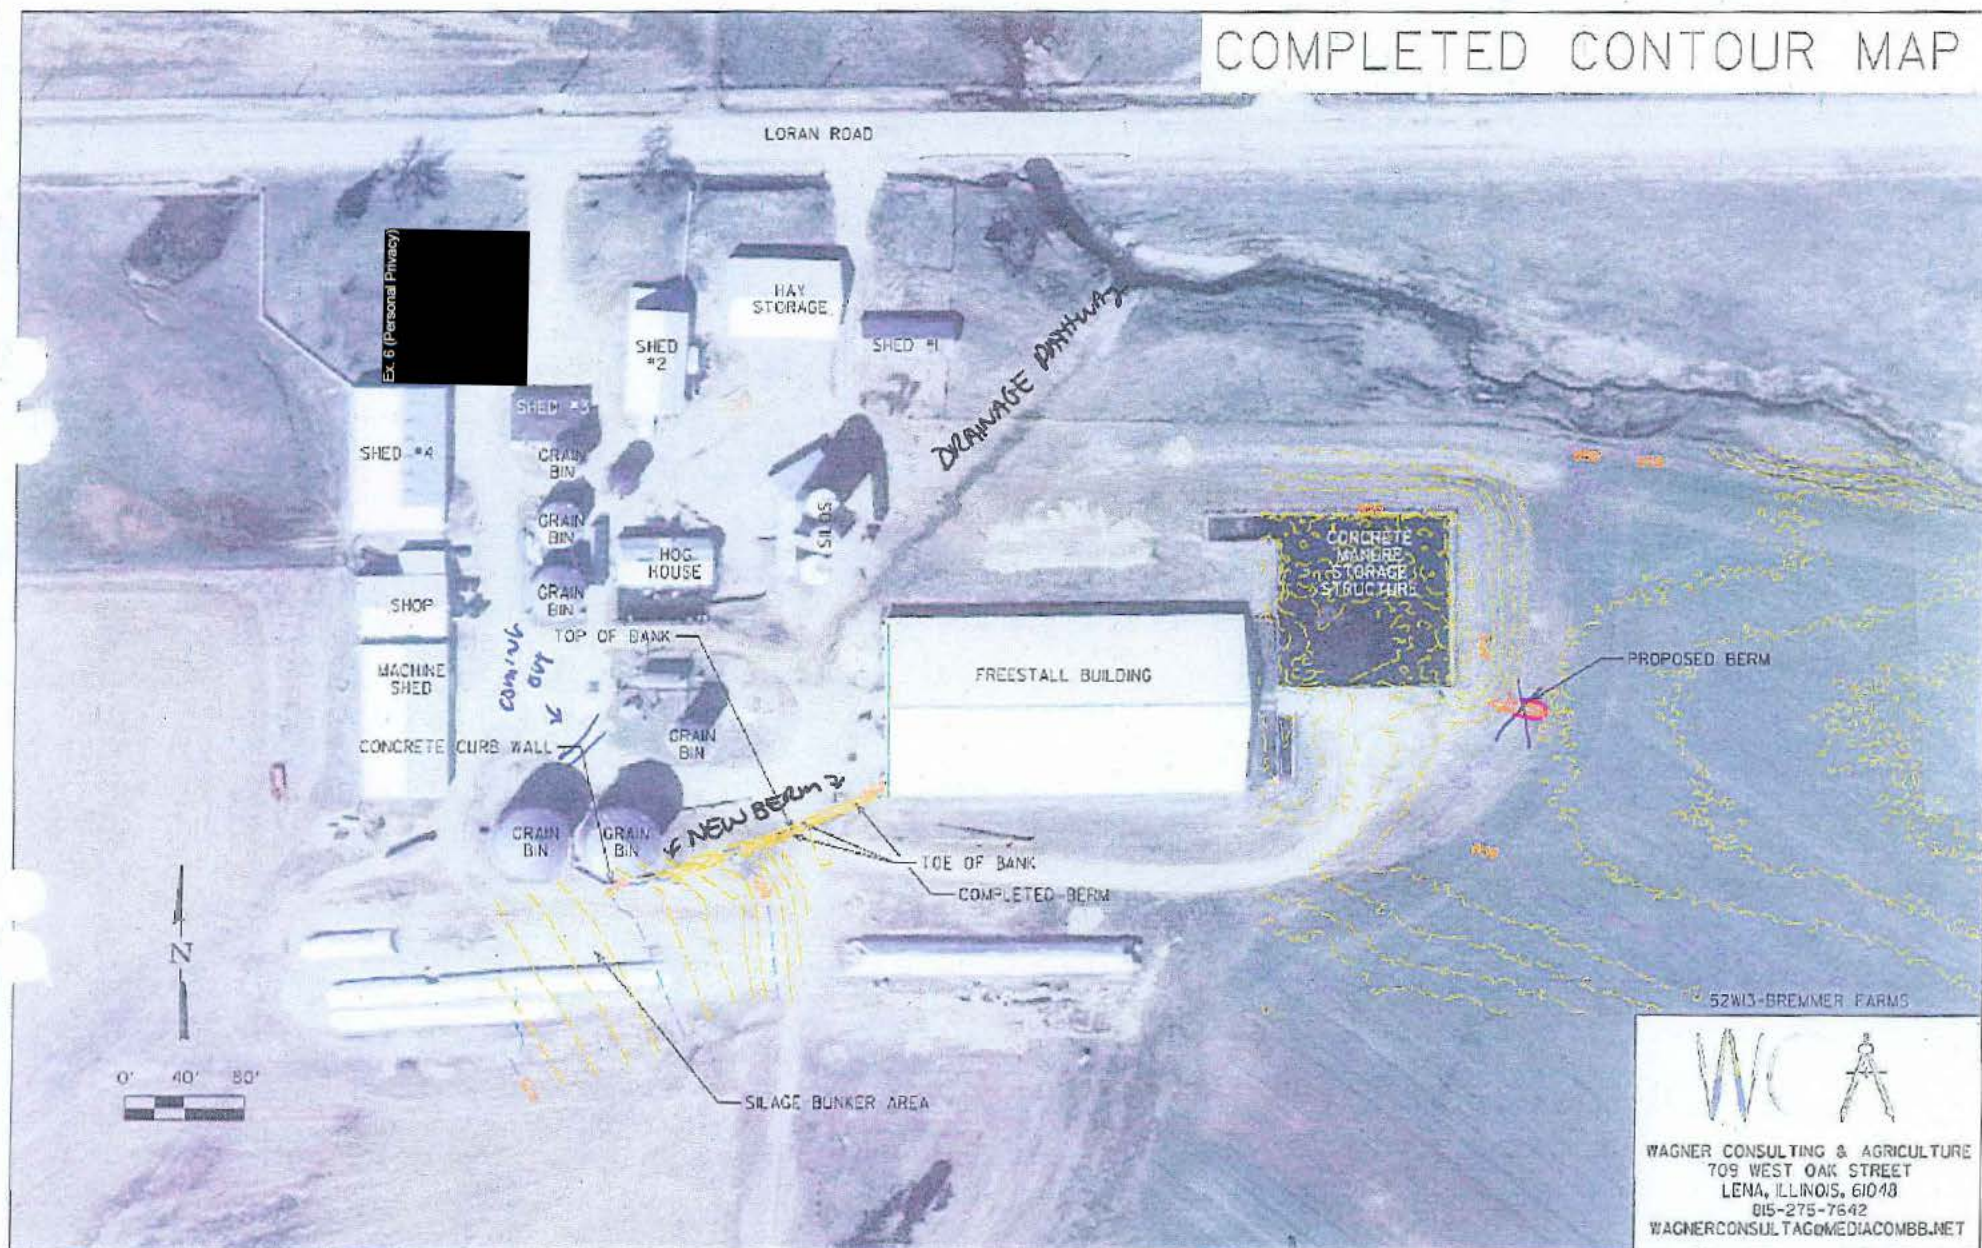
# ATTACHMENT A

Attachment A shows the drainage flow route running northwest from the northeast corner of the freestall building to the unnamed tributary to Spring Branch that had the potential to convey process wastewater from the site before Ex. 6 (Personal Privacy) Farms, Inc. had taken better operation and management practices regarding containment of manure, used bedding and food stocks at the silage, haylage and distillers mixing area.

“Attachment “A”, Completed Contour Map prepared by Wagner Consulting & Agriculture showing the constructed berm and contours.
